Manhole Inspection Summary

Manhole # S55M__016MH

Insp Date: **12/30/08 2:39 PM**

Location Address: **3600 odonnell st**

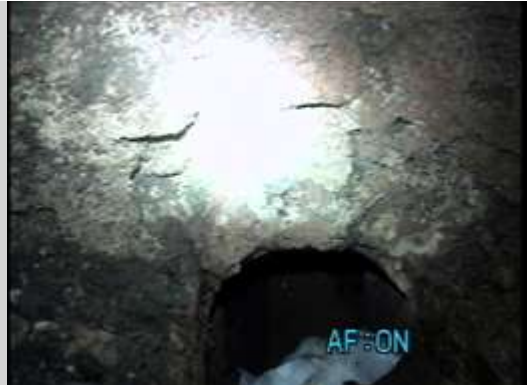
12 O'Clock Outflow

8 in. Circular Gravity Sewer
Pipe Out @ 12 O'Clock

Infiltration: **None** Pipe Seal Cond: **Unknown**
